# Monrojet® (MJ) - Repair Information

January 26 | LGO | V1.4

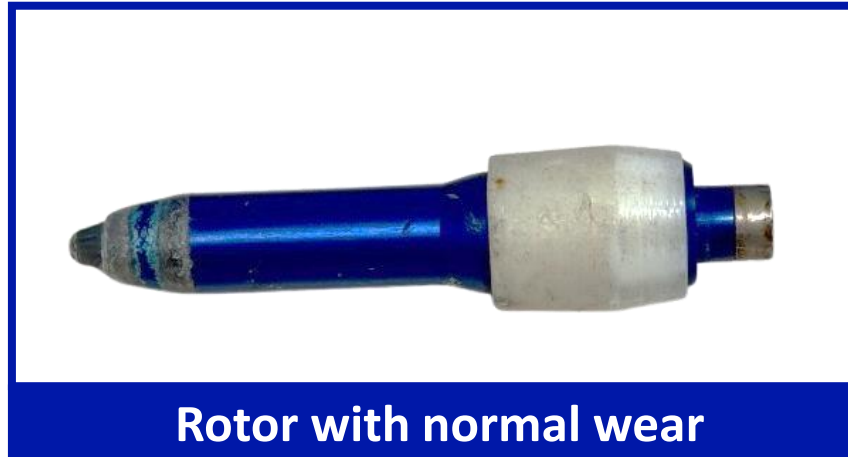
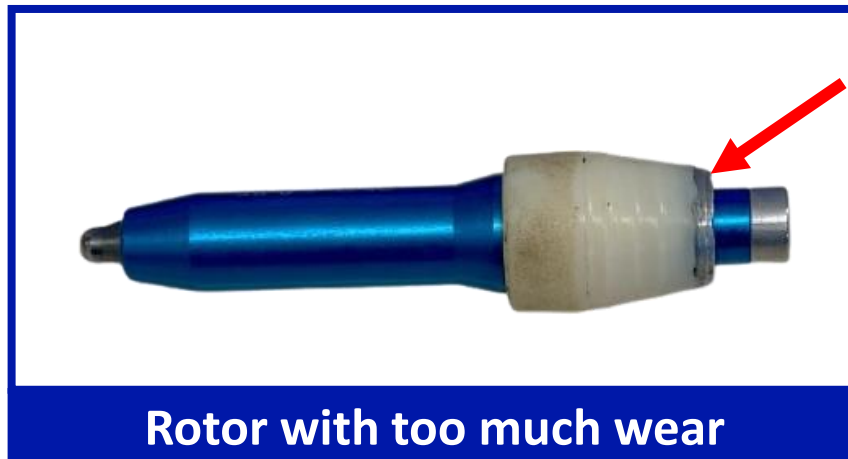
## Normal wear and tear on the rotor

- It is recommended to renew the rotor before the plastic is completely worn.
- If the rotor is worn too much, the nozzle housing may be damaged!

- > 1,000 bar daily check of the individual parts
- < 1,000 bar weekly check of the individual parts

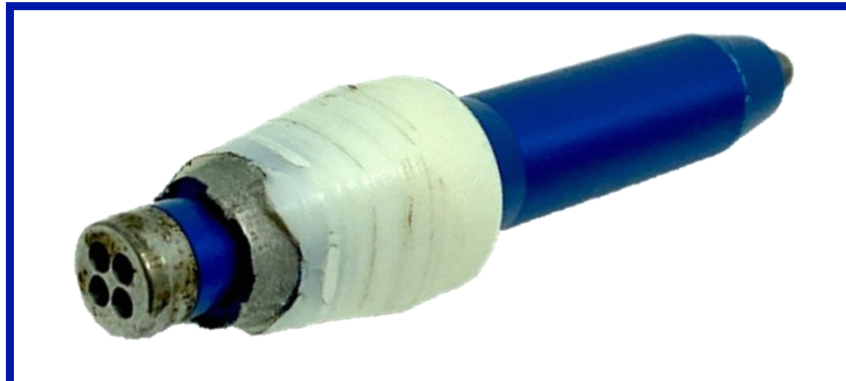
## Damage to the nozzle housing due to a worn rotor

Worn rotor

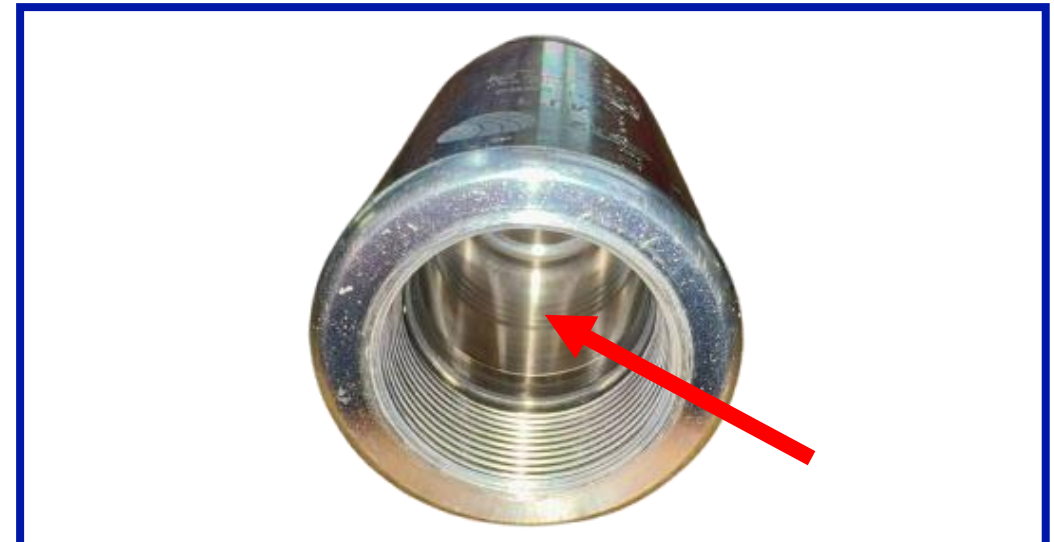
Damaged nozzle housing

A worn nozzle housing must be replaced because it increases rotor wear.

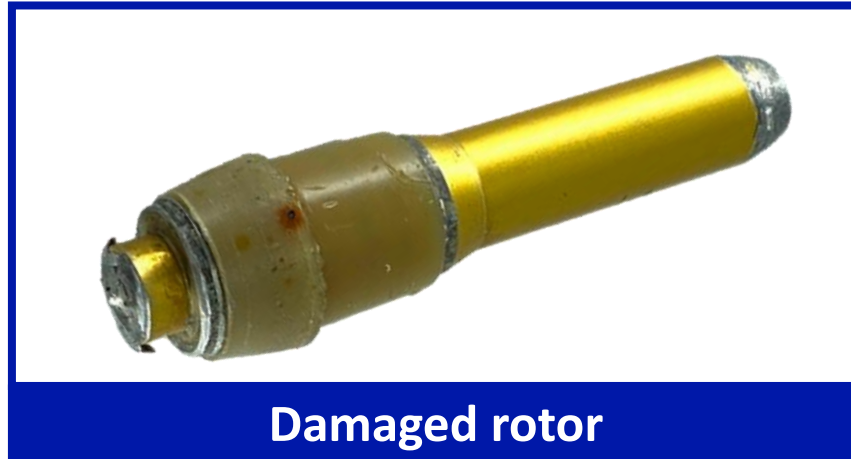
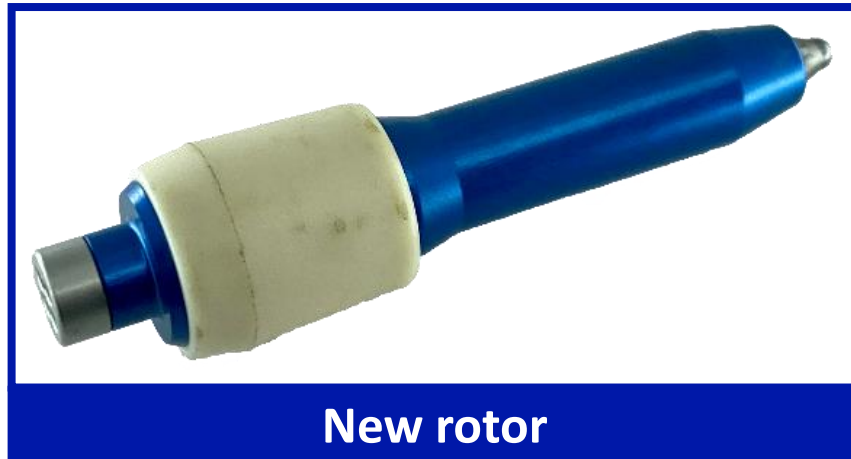
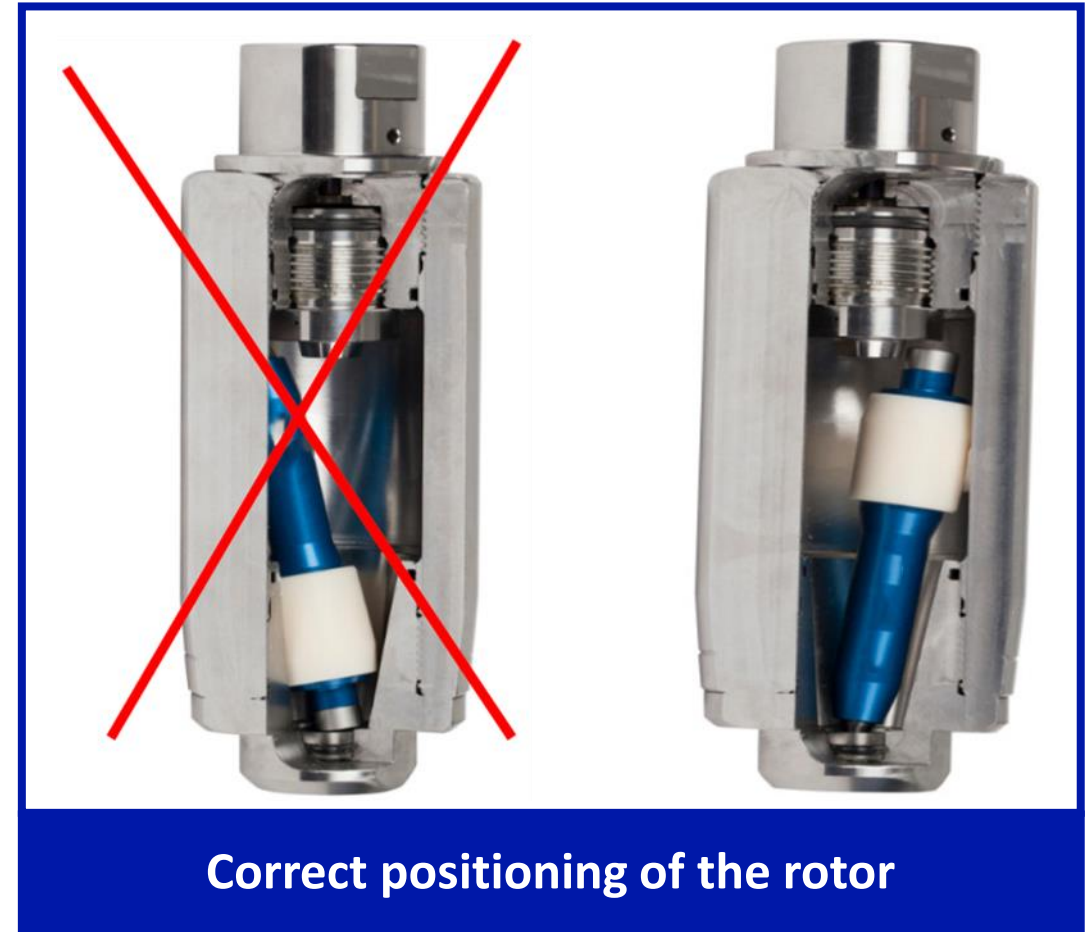
Damage to the rotor due to incorrect installation in the nozzle housing

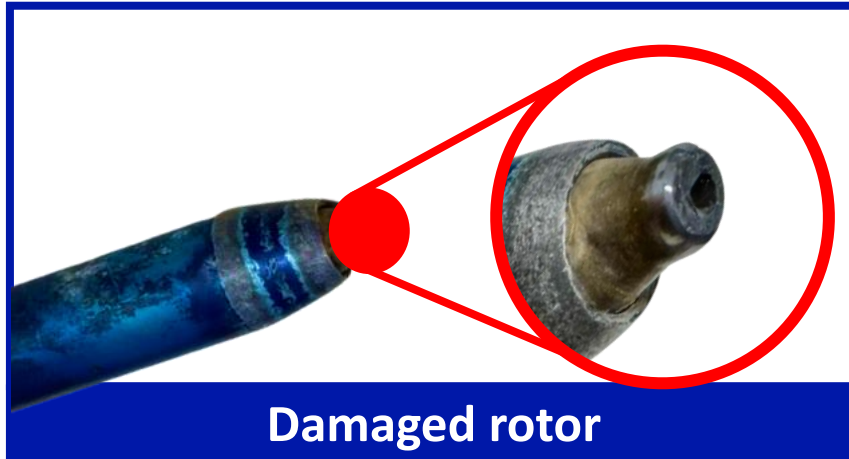
Damage to the rotor tip due to incorrect nozzle positioning at start-up

Damaged rotor

Always point the nozzle downwards during the start-up process.

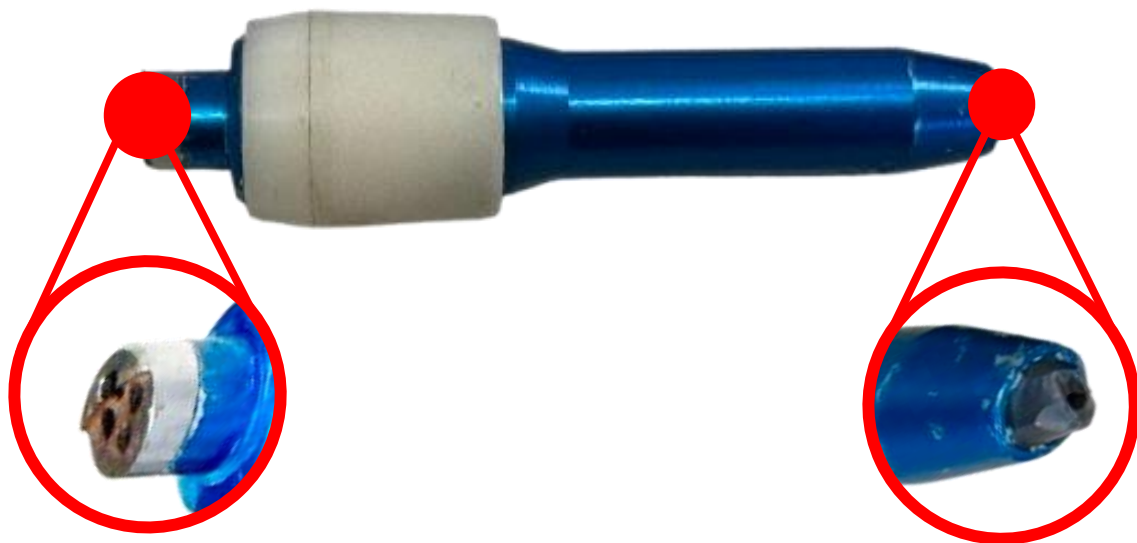
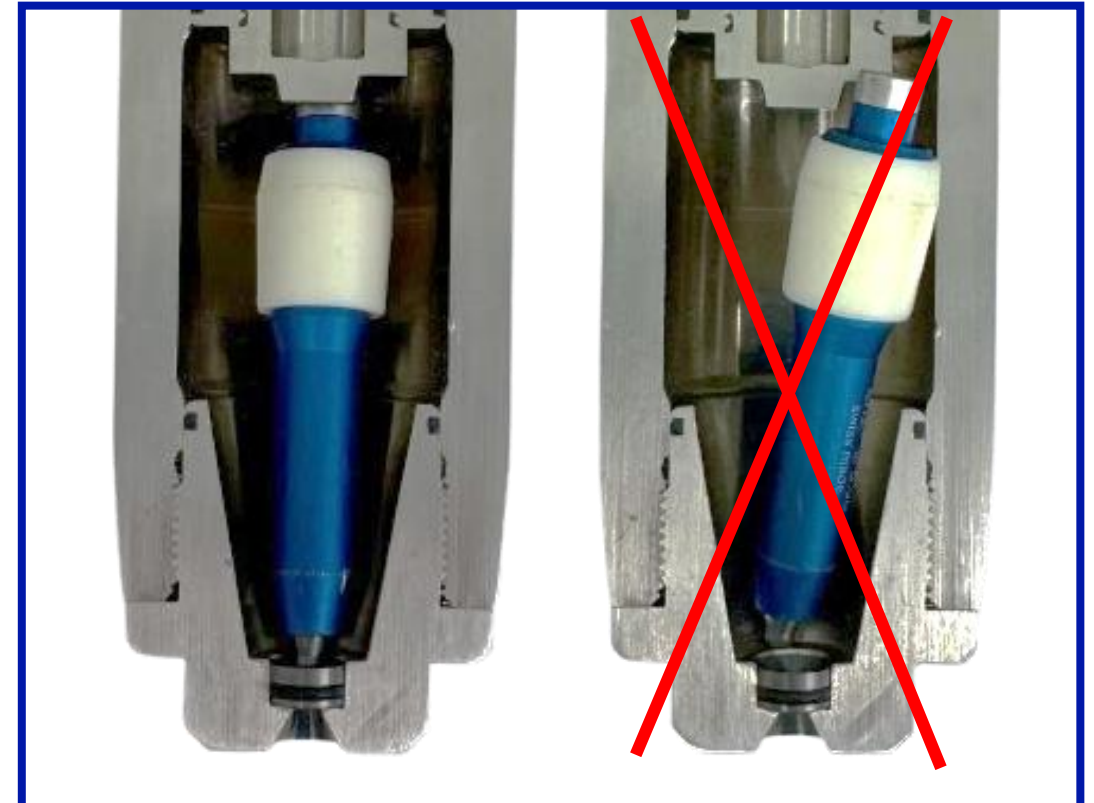
## Damage to the rotor due to incorrect installation

**Always insert the tip of the rotor into the cone**

Only tighten the rear housing part hand-tight without using tools!
