# Monrojet® (MJ) - Repair Information

January 26 | LGO | V1.4

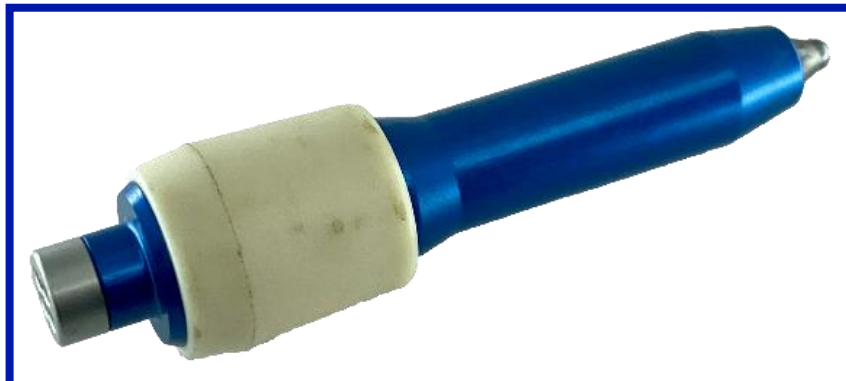
New rotor

## Damage to the nozzle housing due to a worn rotor

A worn nozzle housing must be replaced because it increases rotor wear.

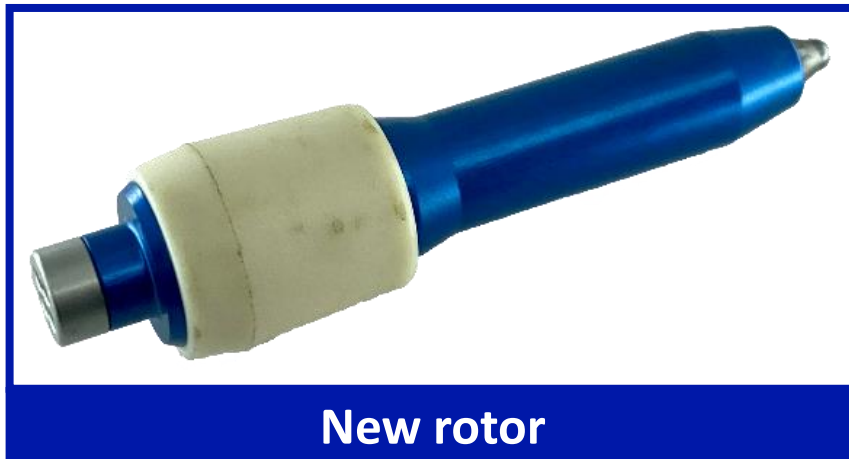
New rotor

Damage to the rotor tip due to incorrect nozzle positioning at start-up

Always point the nozzle downwards during the start-up process.
